**GEOTECHNICAL INVESTIGATION
ALTON MILLPOND AND DAM
VILLAGE OF ALTON
TOWN OF CALEDON**

**ALTON MILLPOND REHABILITATION COMMITTEE
c/o THE ALTON DEVELOPMENT INC.**

**SARAFINCHIN Associates Ltd.
Consulting Engineers**

Project T1874
20 February 2015

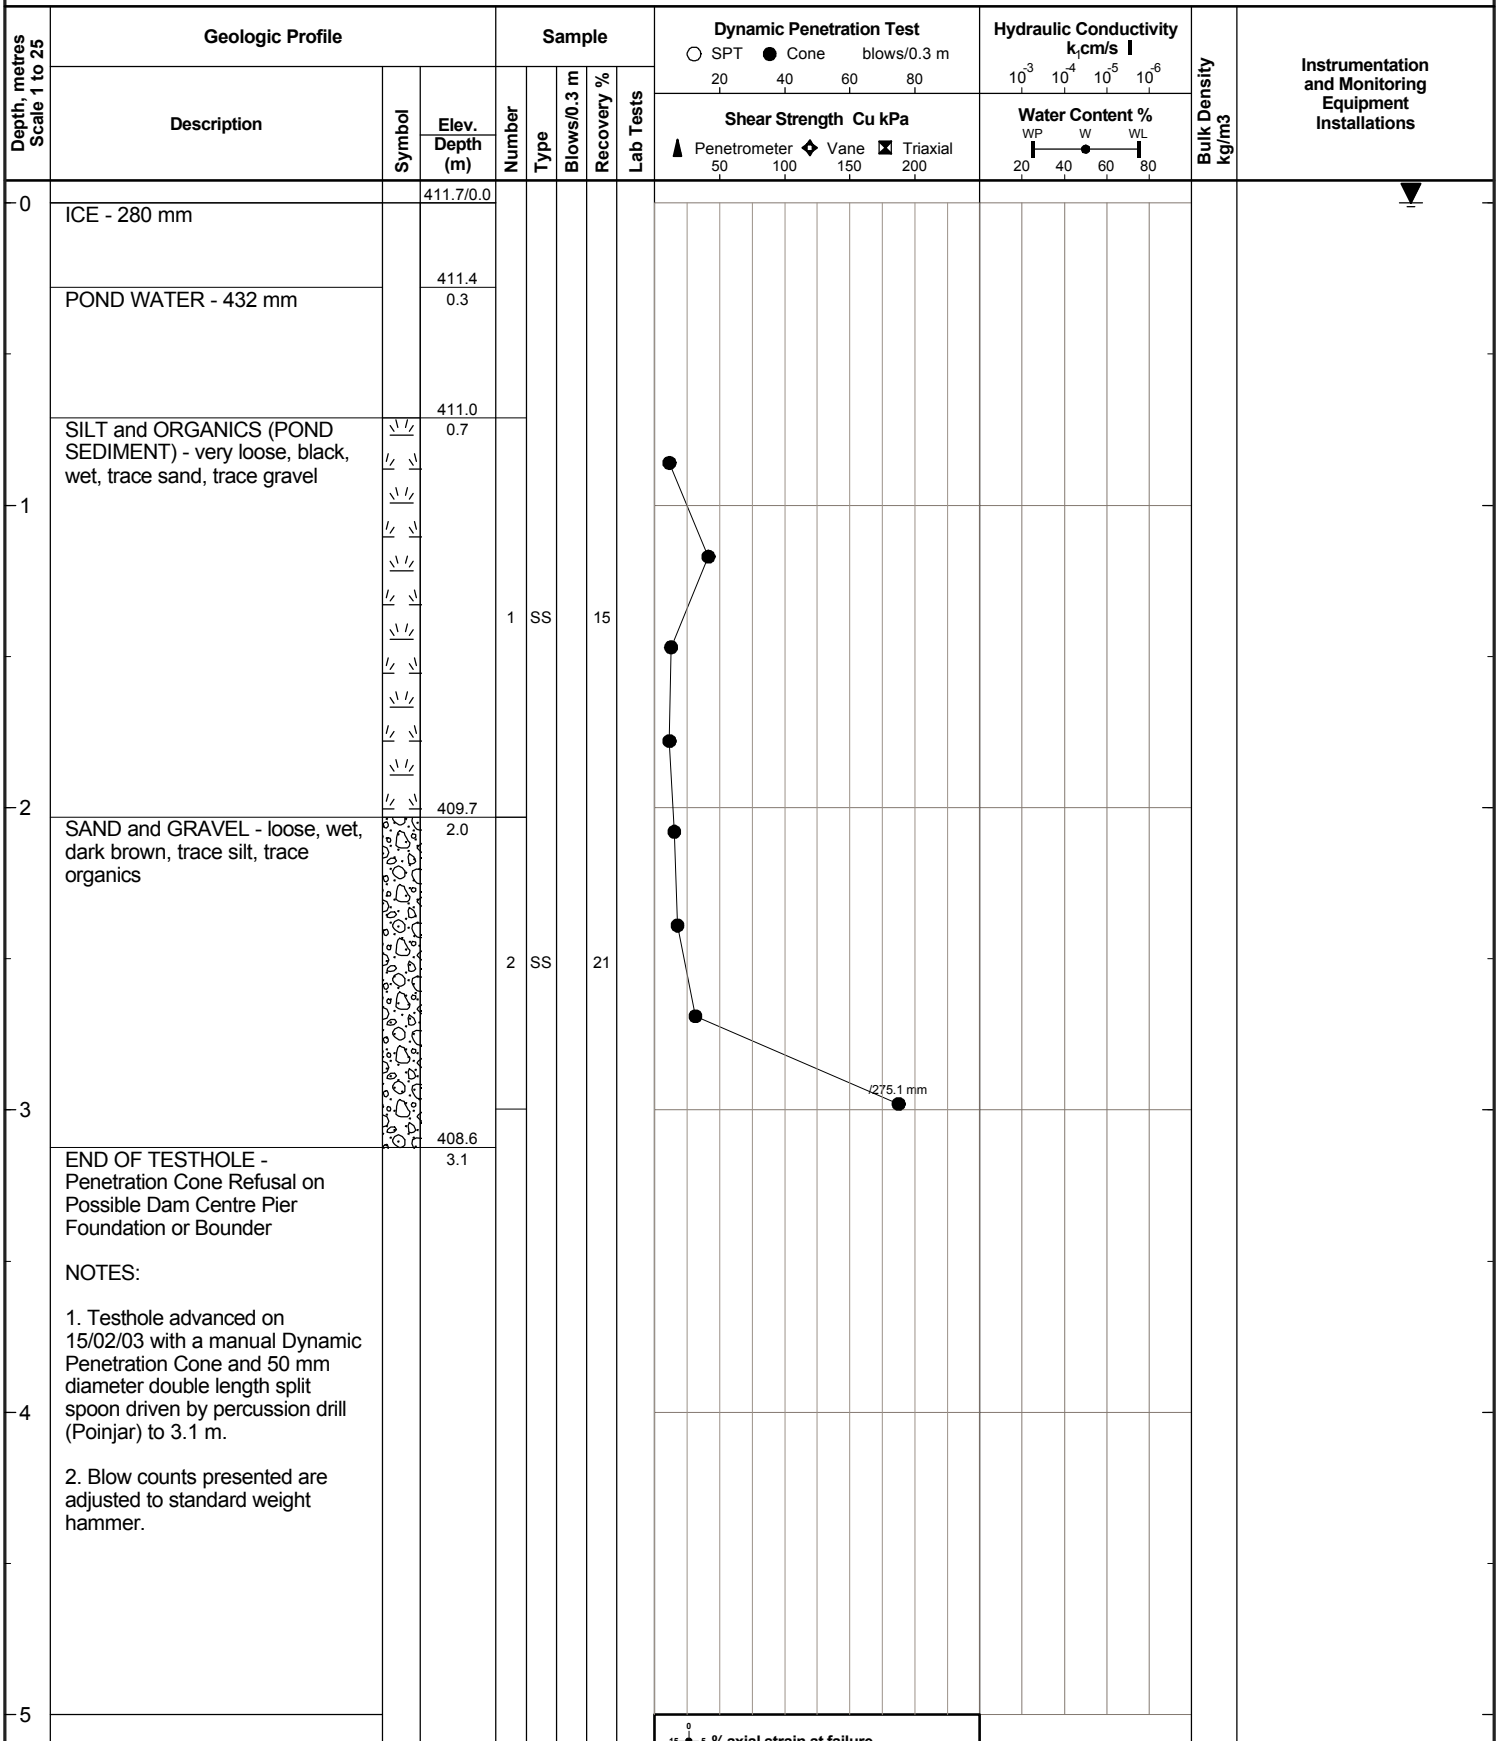
Figure No. 9

The Testhole TH1 was terminated at a depth of 3.1 m due to penetration cone refusal. This refusal elevation is above the prevailing bedrock levels at other testhole locations, and therefore it is probable that the refusal is due to a possible extension of the dam centre pier foundation, or a boulder obstruction.

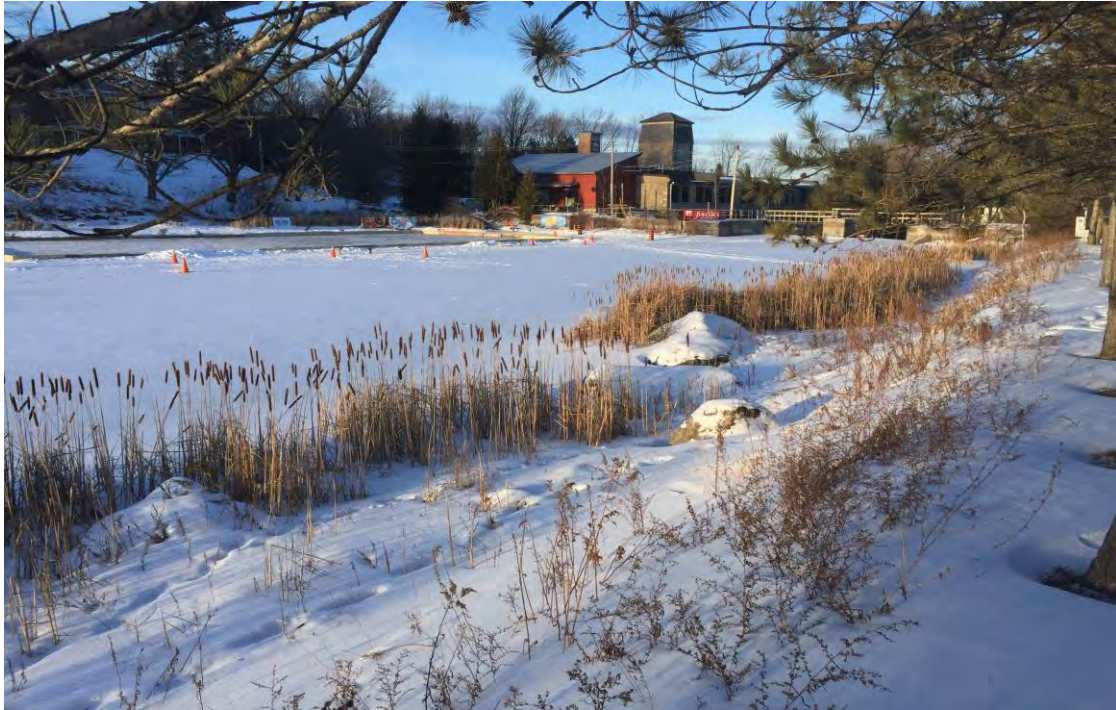
Photo 1– View of Millpond with heritage mill building and dam in background

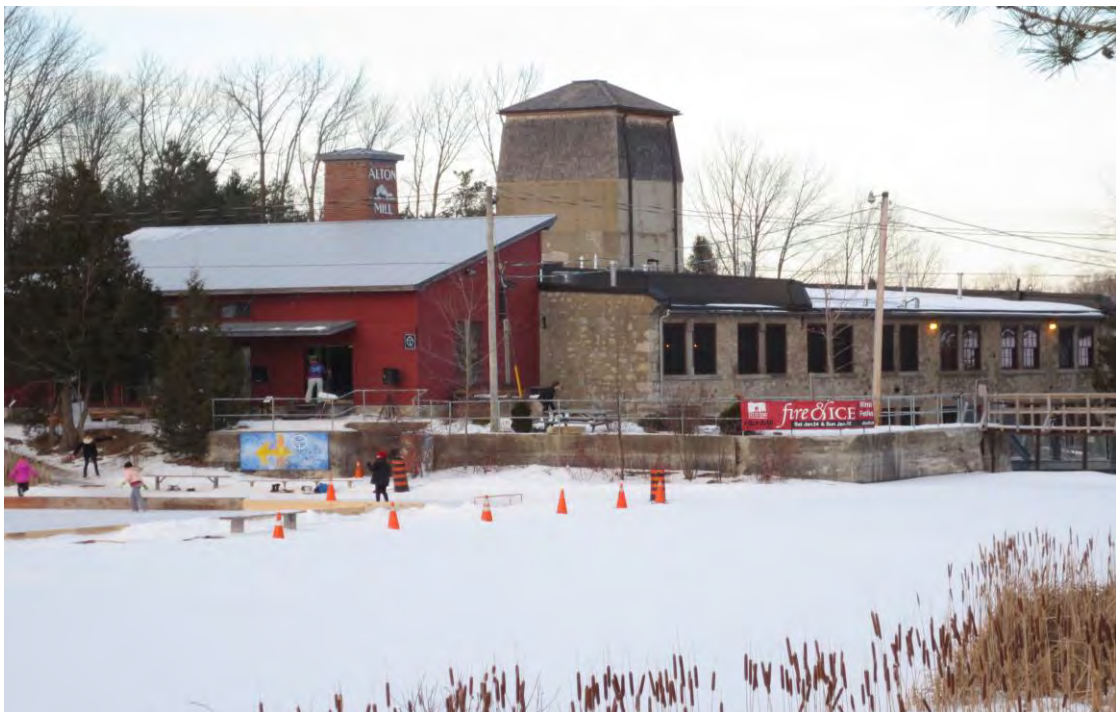
Photo 2 – Upstream Millpond and heritage mill building

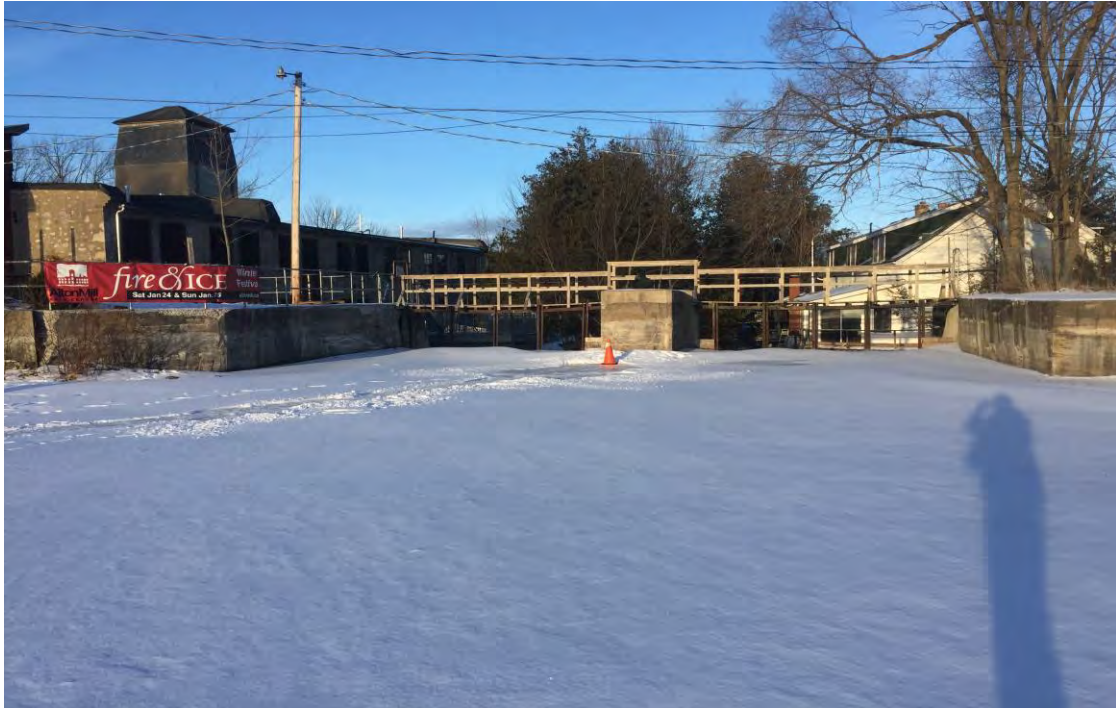
Photo 3 – Upstream headpond and Alton Dam, looking east

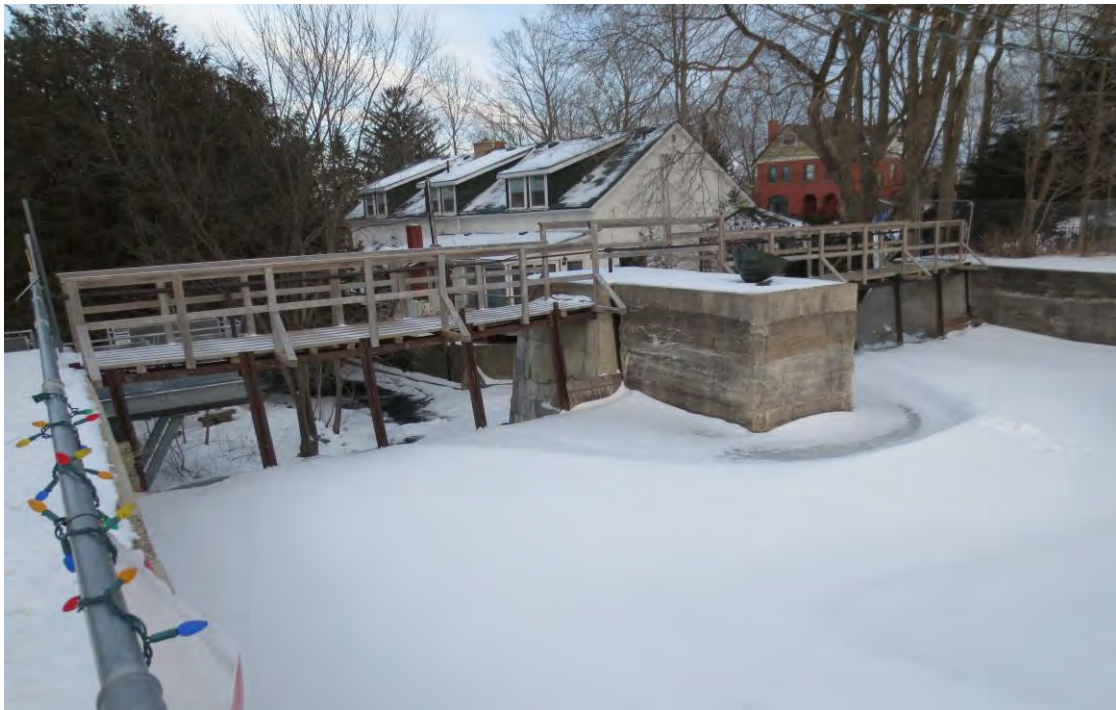
Photo 4 – Two weirs and centre pier of Alton Dam

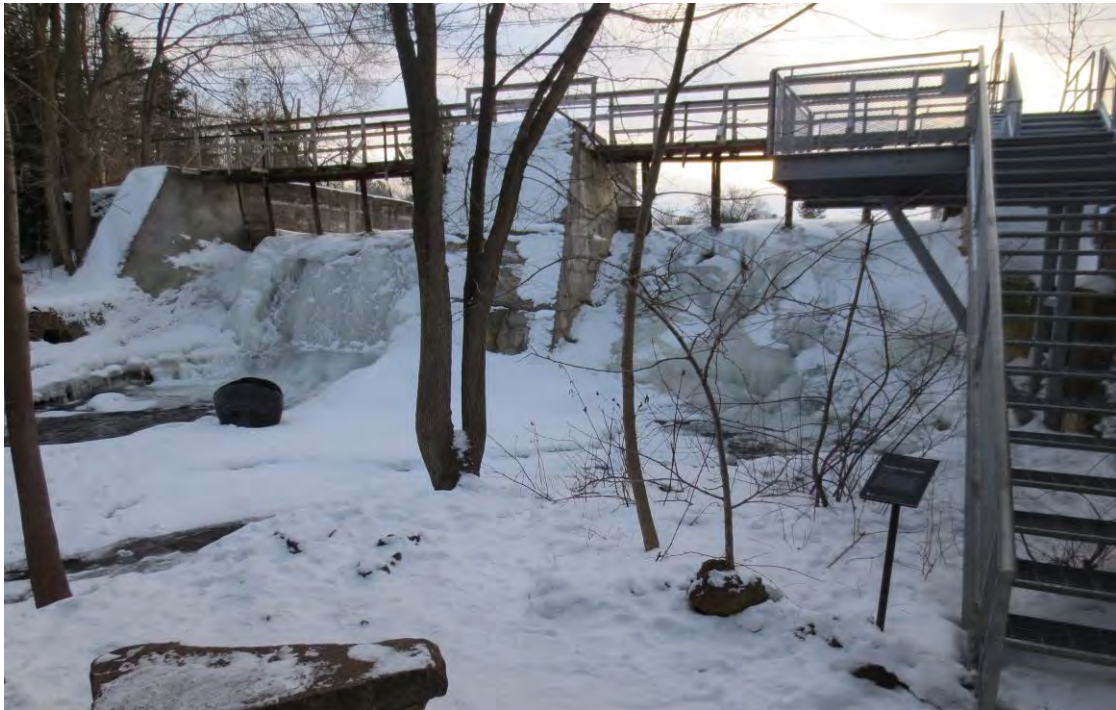
Photo 5 – Alton dam weirs, view from Shaw's Creek north bank downstream of dam

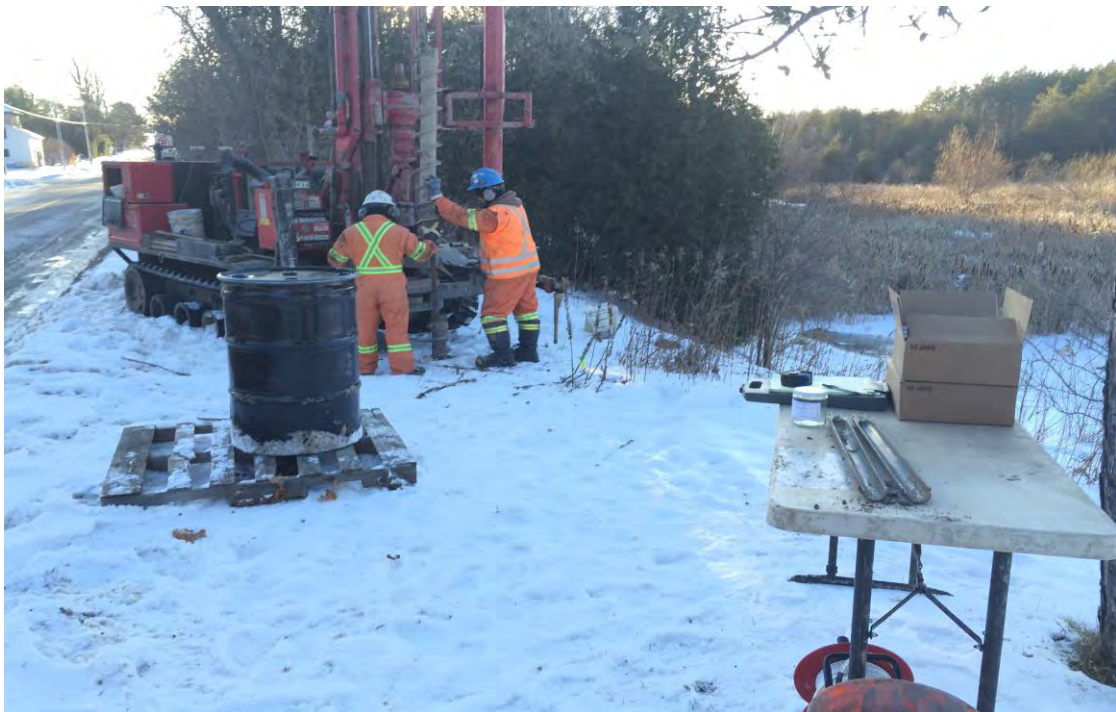
Below the surficial topsoil the boreholes encountered fill extending to depths of 2.4 m in BH 3A and 1.2 m in BH 3B. The fill was observed to be predominantly loose to compact, silty sand and gravel. The silty sand and gravel is characterized by SPT values of $N = 7$ to 12 blows/300 mm penetration.

Photo 6 – Geotechnical drilling and sampling at BH 3A
