Re: Alton Mill Pond Rehabilitation Project
Town of Caledon
Our Project No. 10179.450

Alton Mill Pond

Pond Sediment Depth Measurements
and Core Locations

Stratigraphic Profiles from Coring Sites 1 to 5

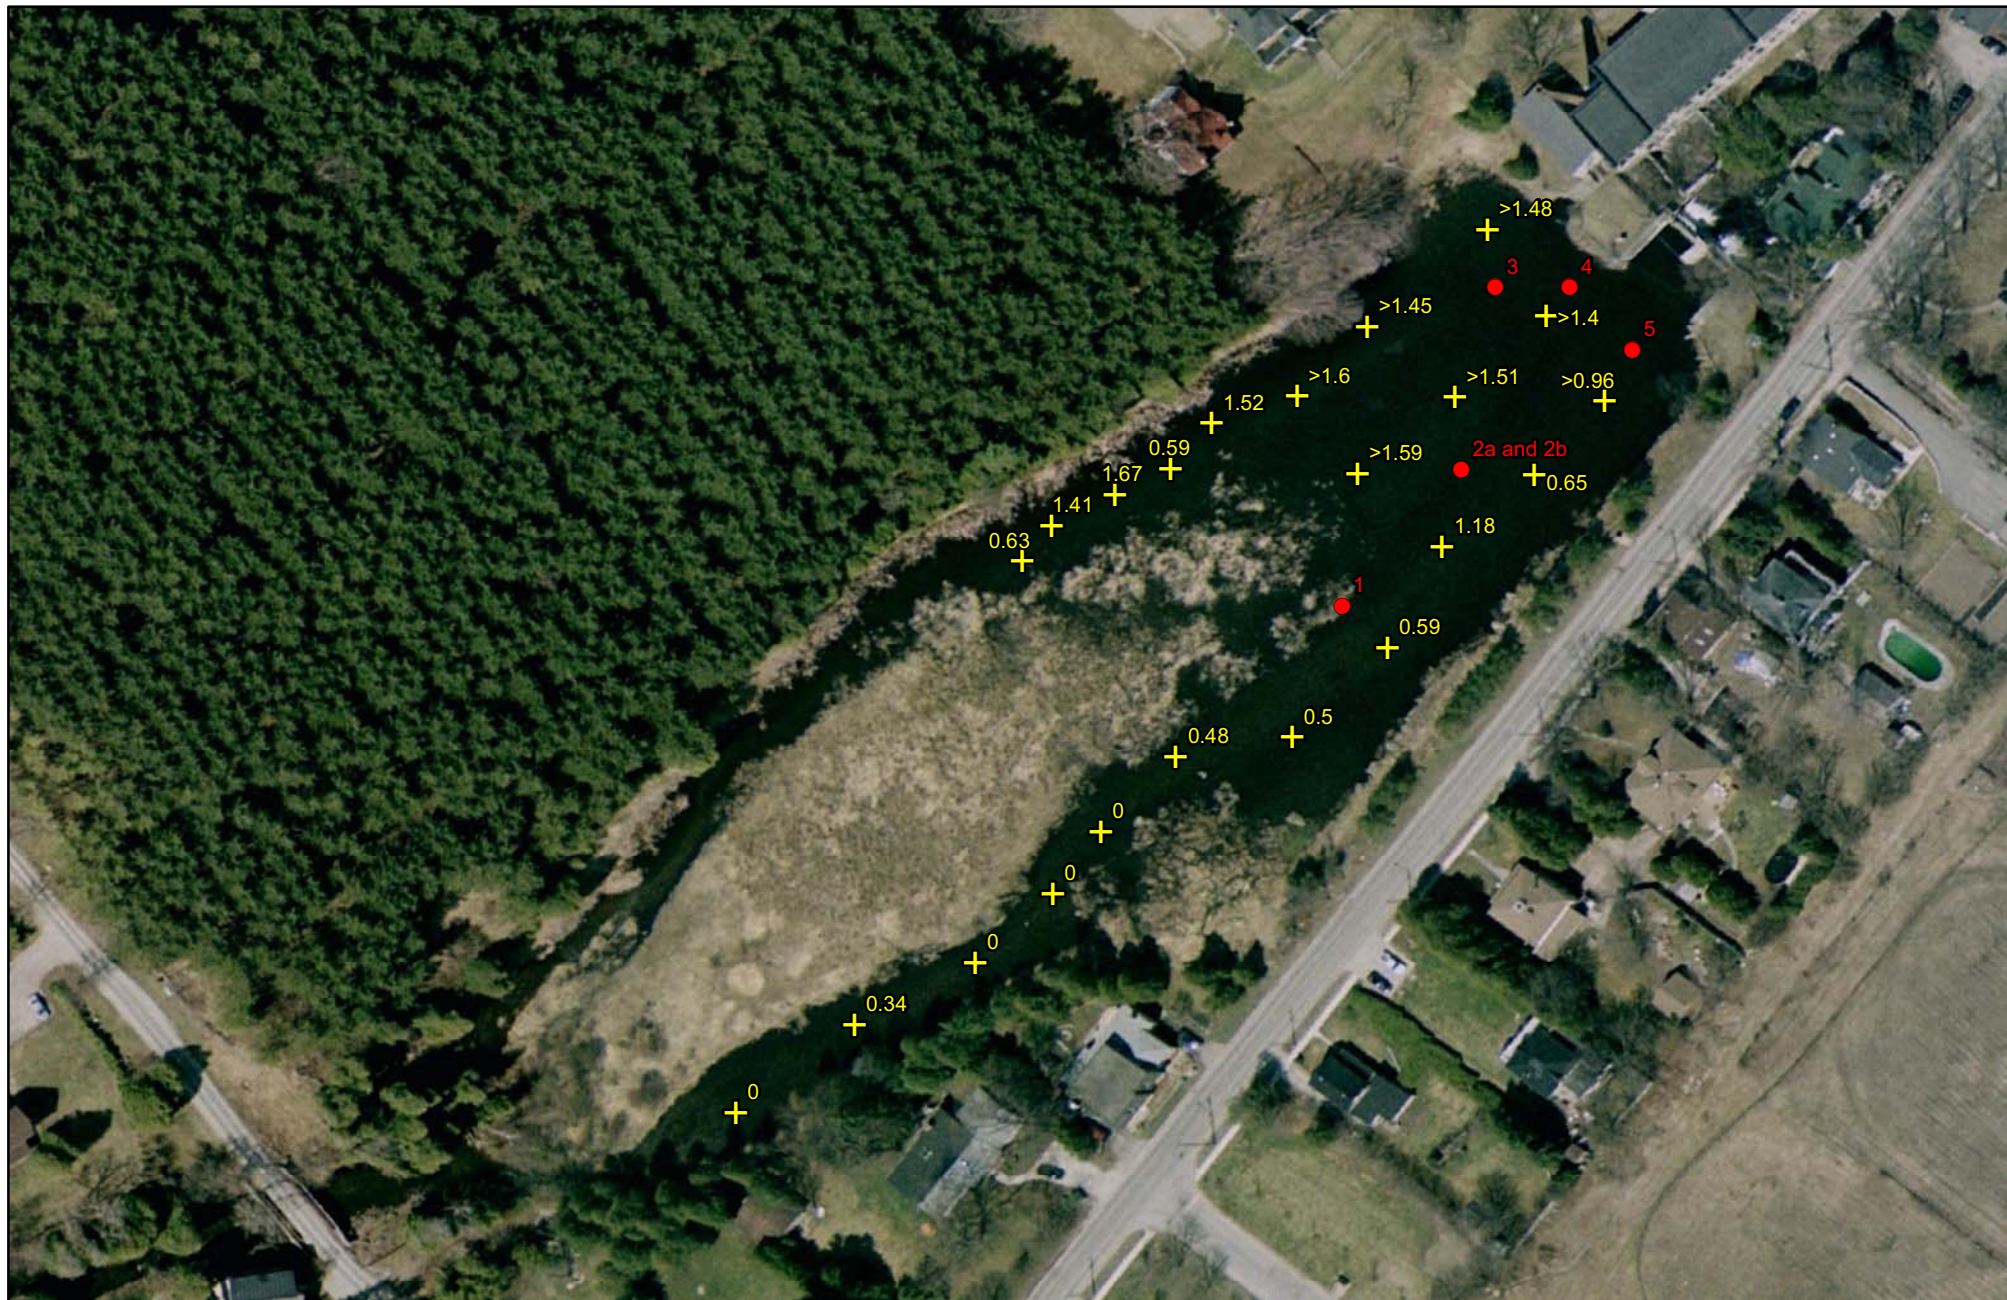
APPENDIX A

- Core Locations
- + Sediment depth measurements (m)

Estimates of sediment depth were obtained during a second field visit on June 4, 2010. Sediment depth and water depth were measured at 22 locations in the pond using a metal rod and geo-referenced using a RTK GPS system in order to obtain a rough estimate of sediment volume. Sediment depths are shown in **Appendix A**. Generally the greatest sediment depths were encountered in proximity to the dam structure and along the north side of the pond where velocities are relatively low. Note that in many instances sediment depth measurements were limited by the length of the rod. As such, in some locations only the minimum sediment depth could be calculated.

pond and in front of the dam structure. Areas where there was no sediment accumulation, noted with values of 0 in **Appendix A**, were not included in the calculations. The area of the pond where sediment accumulation was occurring was measured to be 6,033 m or 0.6 ha. This value was then multiplied by the average and maximum sediment depths, which were 0.89 m and 1.67 m, respectively. These simple calculations result in an average sediment volume estimation of 5,361 m³ and a maximum sediment volume estimation of 10,075 m³.

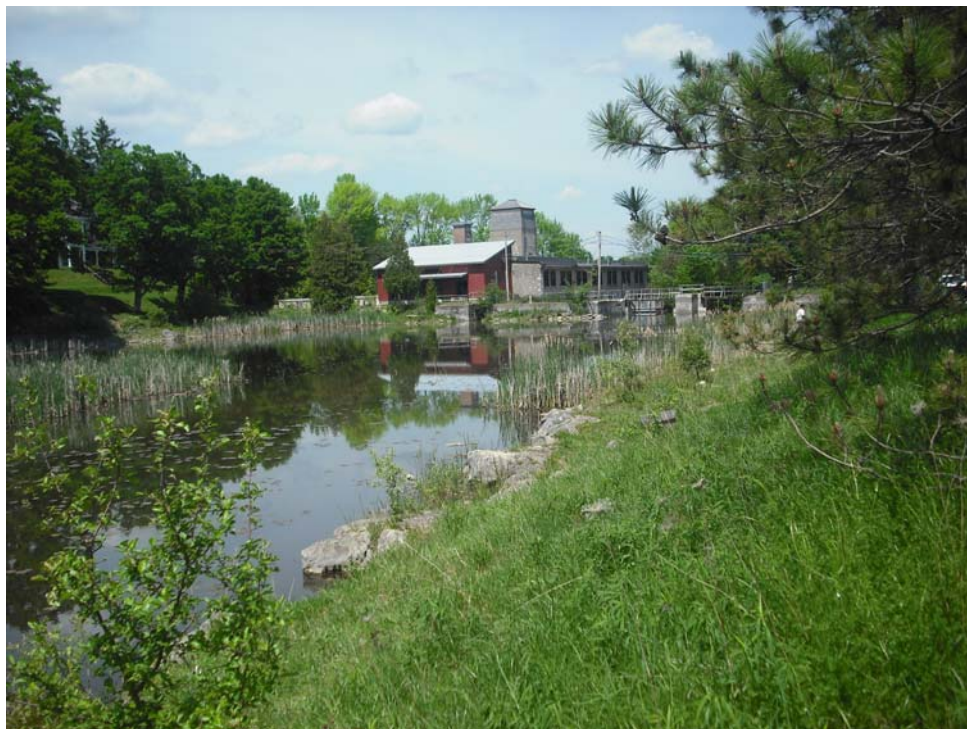
Photo 1.

View to the northeast of Alton
Mill Pond

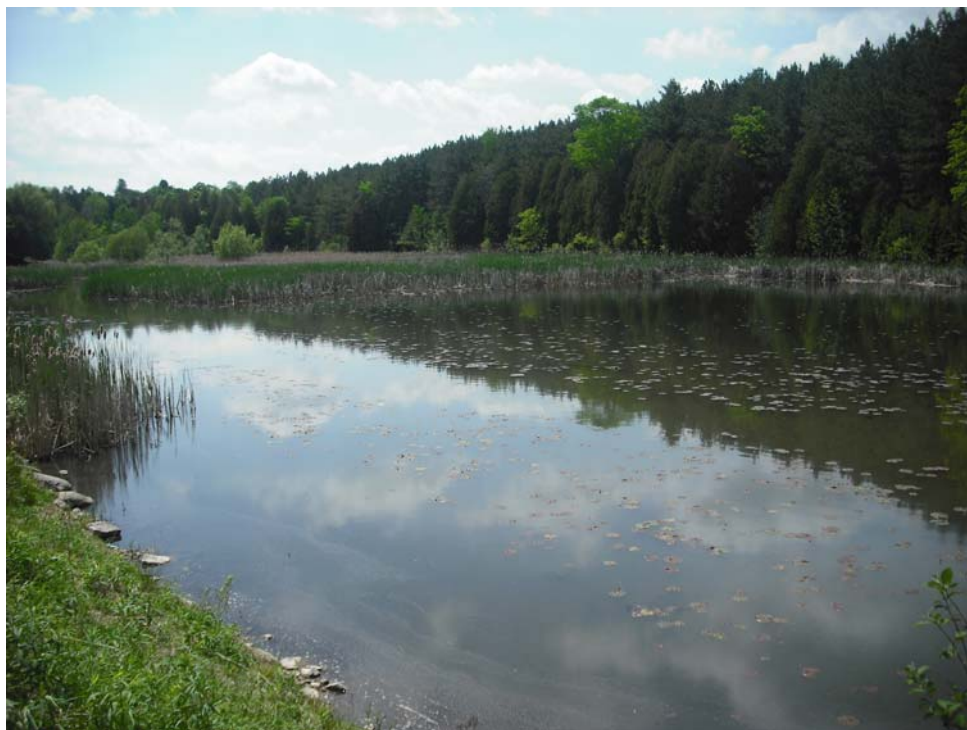
Photo 2.

View to the southwest of Alton
Mill Pond. Lillipads occurred
throughout the pond. Carp were
also observed during field work

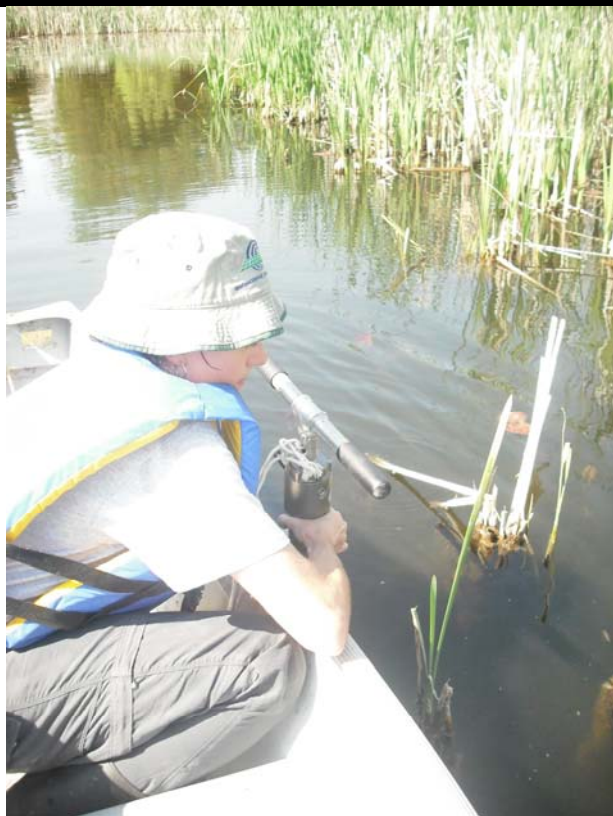
Photo 3.

The 1.5 m Ogeechee Corer was used to collect sediments from 6 locations in the pond for stratigraphic analyses.

Field work was completed with the assistance of staff from Credit Valley Conservation on May 28, 2010. Six sediment cores were collected from five sites using a 1.5 m long, 0.05 m diameter Ogeechee Corer and ranged from 0.26 m to 0.5 m in length. The corer was penetrated as far as possible and a valve was closed (acting in the same manner as a rubber stopper on a syringe). The corer was then recovered and the sediment core was removed and capped for later analyses. This type of sampling apparatus is used to collect cores for stratigraphic analyses because the integrity of the sedimentary structures are retained upon collection. Sediment core locations are shown in **Appendix A**.

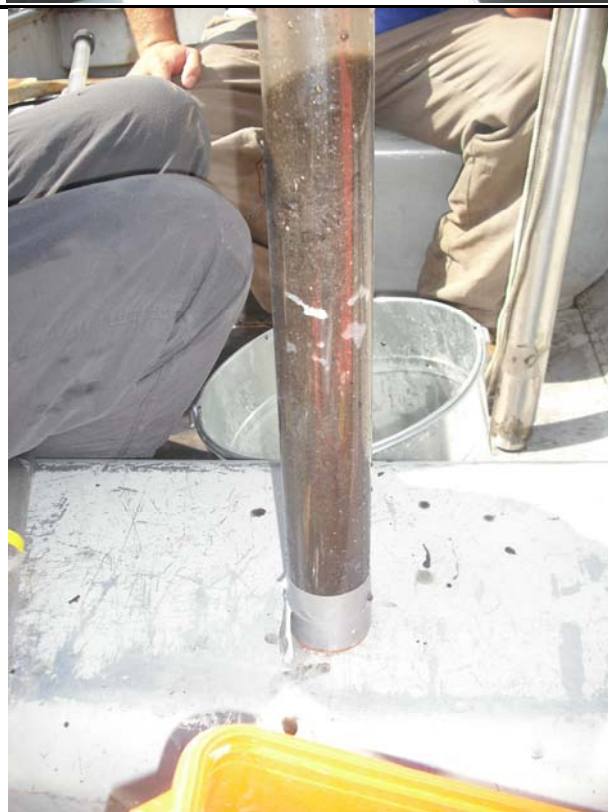
Photo 4.

A typical core collected from the Pond using the Ogeechee Corer. Sediments were generally organic rich and massive, and contained largely fine grained sediments.

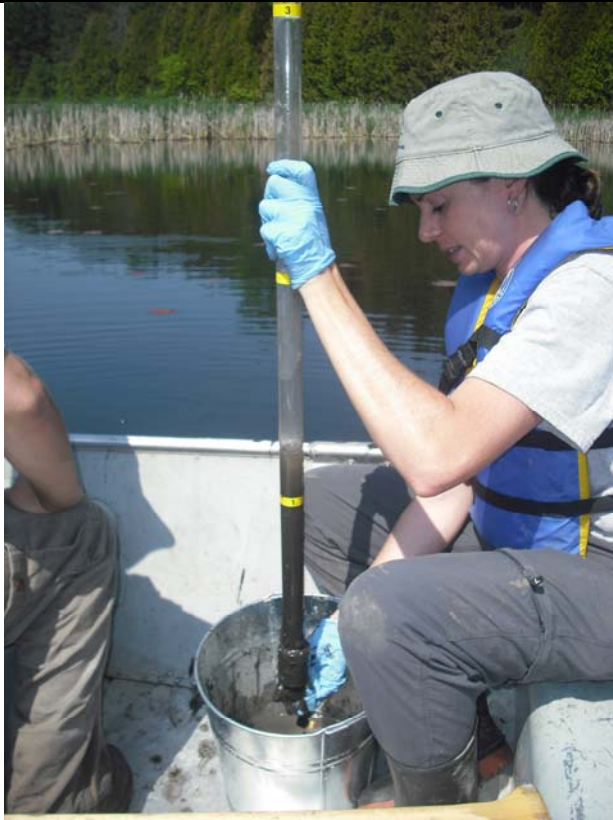
Photo 5.

Additional sediment was collected from each of the coring locations and was combined to form a composite sample for sediment testing.

The composite sample, collected from the same sites as the sediment cores, exceeded the standard for electrical conductivity, as outlined in Table 2 of Ontario Regulation 153/04 for soil and is highlighted in grey in **Appendix C**. Electrical conductivity, or total dissolved solids (TDS), is a measure of the number of dissolved ions in a substance. Although the sediment collected near the storm outfall did not have high electrical conductivity this may be a function of sediment grain size (the sample consisted largely of sand, which does not attract ions as efficiently as clay particles) and the time of year that the sample was taken (spring melt and run-off had occurred by the end in March). Given the proximity of the pond to the road, and taking into account the untreated discharge from the storm outfall to the pond in the spring, it was initially assumed that the electrical conductivity results indicated a significant concentration of salt. However, the sodium adsorption ratios (SAR) for both samples were well within the guidelines provided in **Appendix C**, albeit the outfall sample had a higher SAR than the composite sample. SAR represents the ratio of the concentration of sodium to that of calcium and magnesium (Al-Hamaiedeh and Bino, 2010).

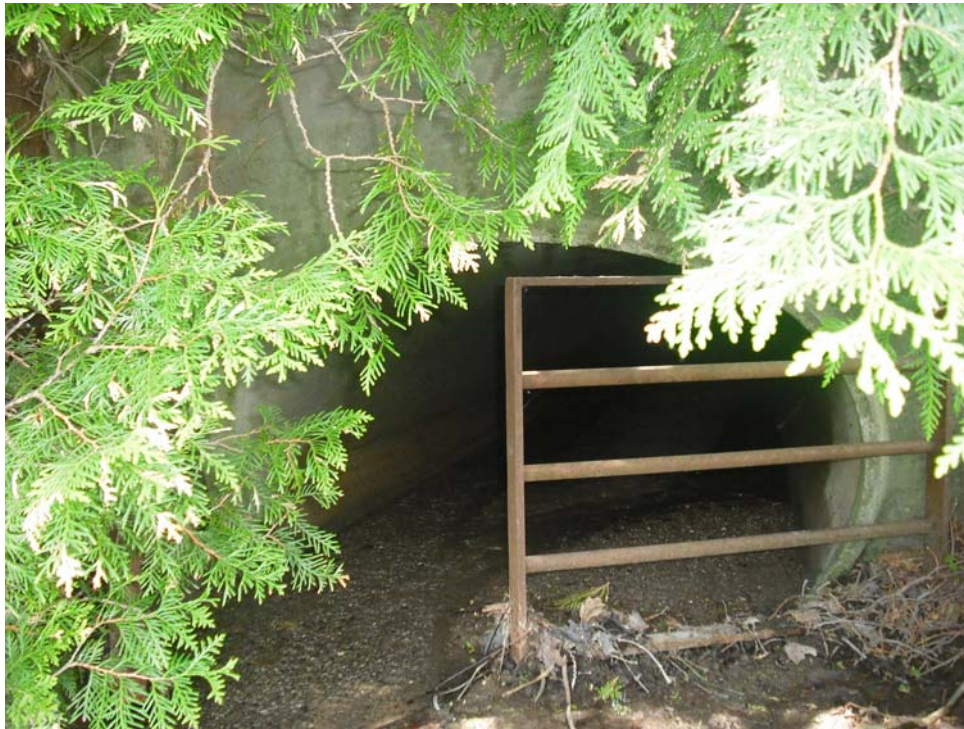
Photo 6.

Sediment grad samples were also collected from the outflow at storm outfall along the south side of the pond adjacent to Queen Street for sediment testing.

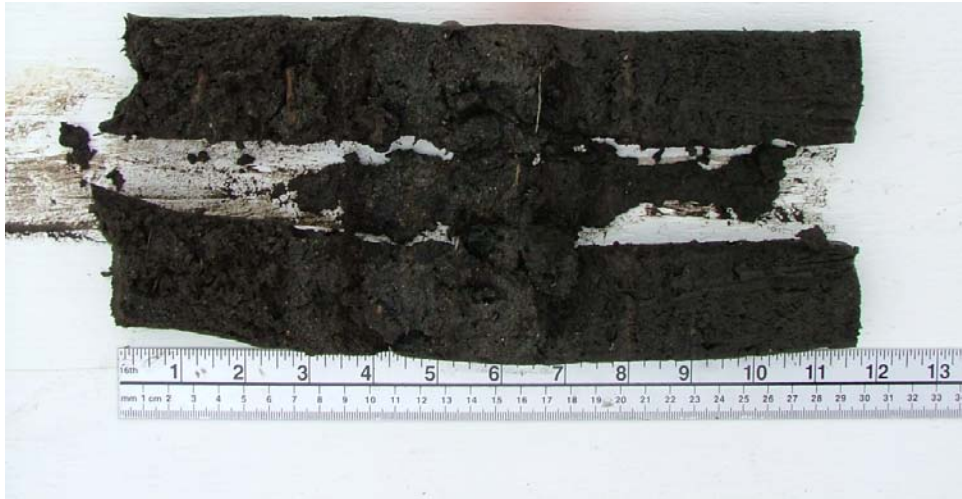
Photo 7.

Sediments were relatively coarse-grained, containing very fine to fine sand and silt. This is likely due to the proximity of the coring location to Shaw's Creek. The top of the sediment core is on the left.

Core 1 was collected furthest from the dam structure and was 28.8 cm in length. This core contained the highest amount of sand and largest grain size when compared to the other 5 cores. From the base of the core to 20.2 cm the sediments consisted of massive black silt, clay and fine to very fine sand. From 20.2 cm to 20 cm there was a thin light brown bed with diffuse contacts. From 20 cm to 16.5 cm the sediments were black and contained relatively large pieces of leaf material and woody debris. From 16.5 cm to 11.5 cm the sediments were dark brown and contained very fine to fine sand. The overlying sediments, from 11.5 cm to the top of the core were black, less 'gritty' than the previous interval, but still contained some fine to very fine sand and silt. Two large pieces of organic material, likely cattail stems, occurred at 10.1 and 8.2 cm.

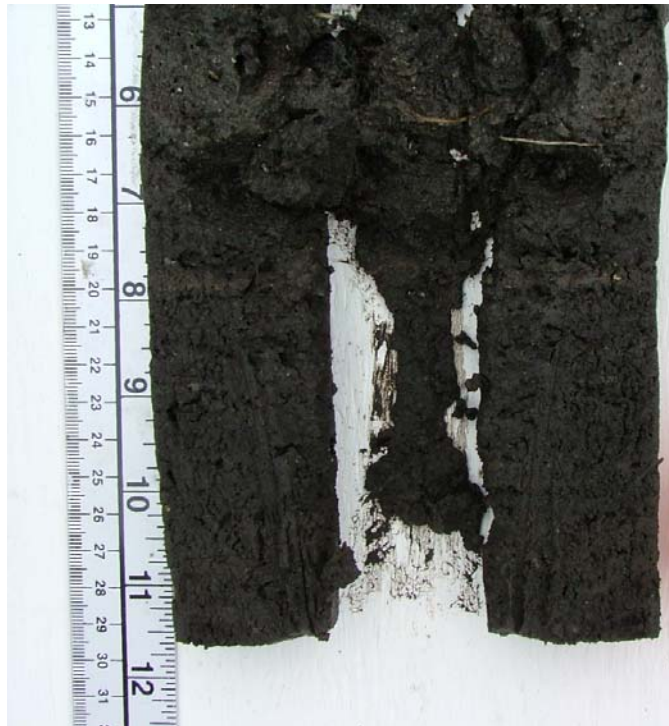
Photo 8.

The sediments near the base of the core consisted of clay, silt, and very fine sand.

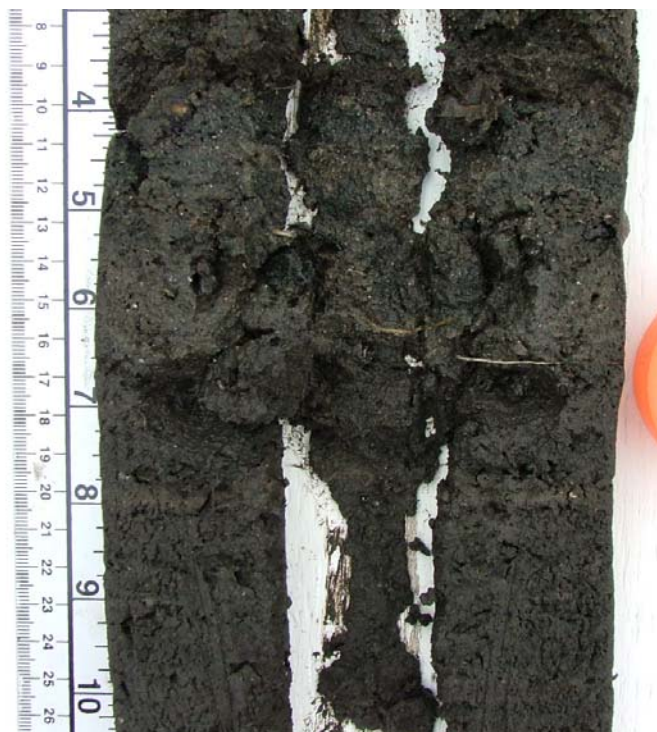
Photo 9.

Note the light brown bed from 20.2 to 20.0 cm consisting of very fine sand and silt.

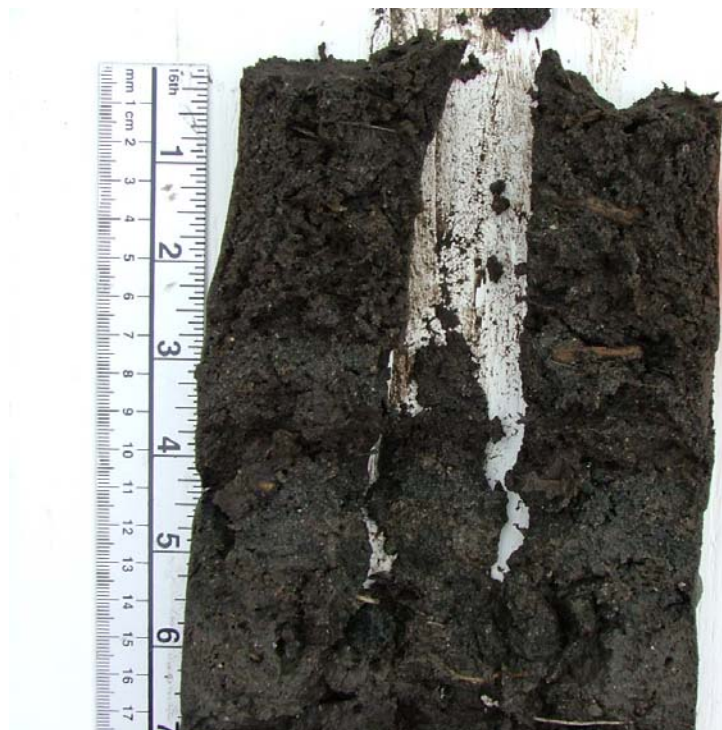
Photo 10.

The sediments near the top of the core. Note the relatively large pieces of plant material, likely cattail stems.

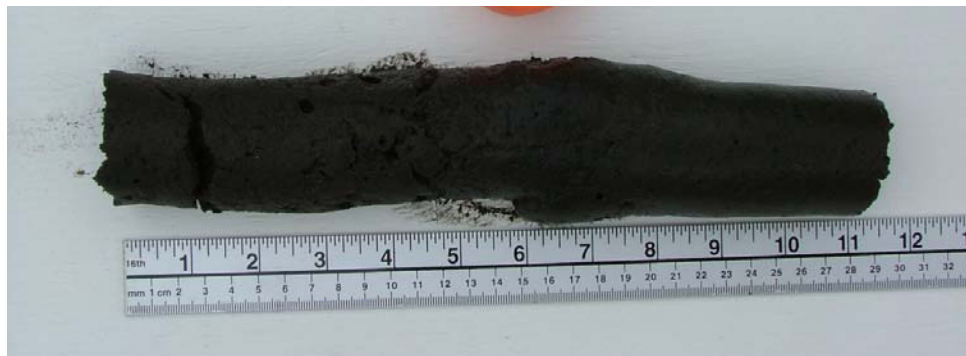
Photo 11.

Sediments consisted of massive silt, clay and organics. There was a concentration of organic matter from 11 to 9 cm. No sedimentary structures present.

Cores 2a and 2b were collected near the center of the pond and were 28 cm and 28.5 cm in length, respectively. Small fragments of organic matter and rootlets were visible throughout both of the cores and there was evidence of gas bubbles. The sediments in core 2a were massive, black clay and uniform in color and texture with the exception of the interval from 11 cm to 9 cm, which contained a concentration of organic debris consisting of pieces of leaf, root and stem pieces. In core 2b, from the base of the core to 13.5 cm the sediments consisted of black clay. There was a concentration of organic matter from 13.5 cm to 12.5 cm with organic pieces ranging in size from 2 to 3 mm in diameter. From 12.5 cm to the top of the core the sediment also consisted of clay.

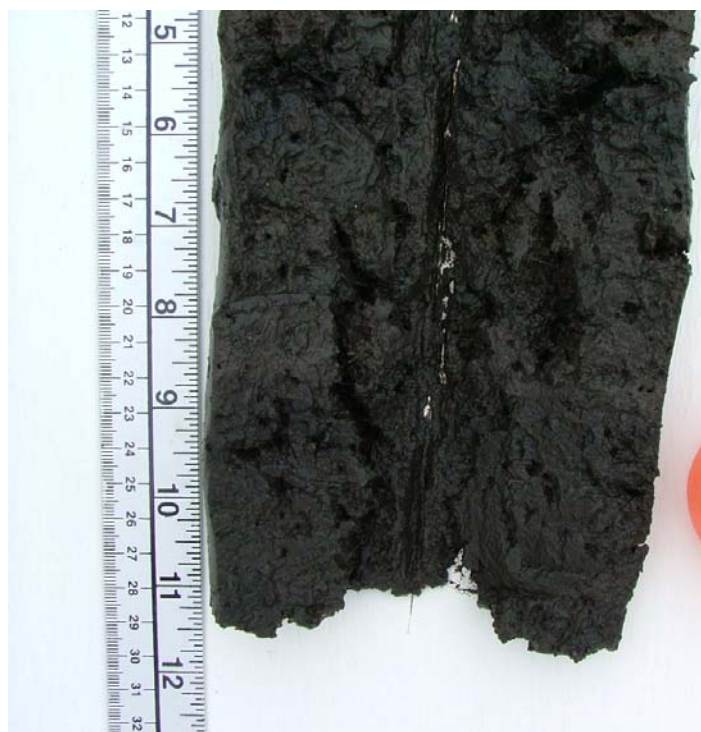
Photo 12.

Sediments near the base of the core.

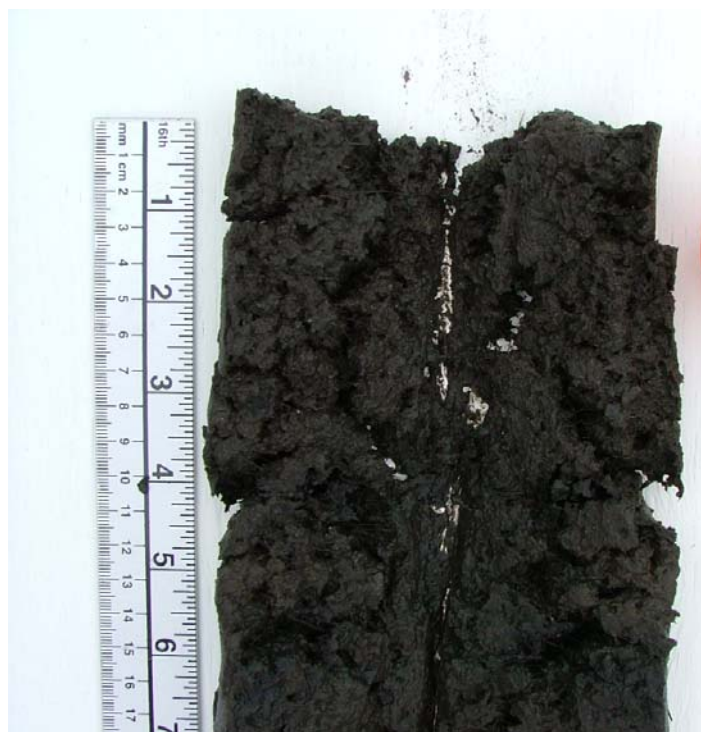
Photo 13.

Sediments near the top of the core.

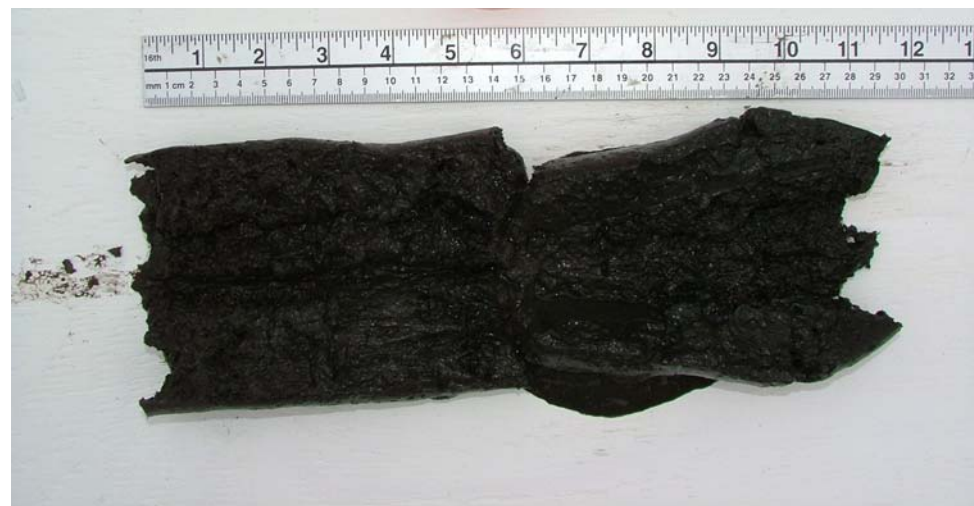
Photo 14.

The core was comprised of massive, saturated silt and clay, and also contained small fragments of shell. No sedimentary structures were apparent.

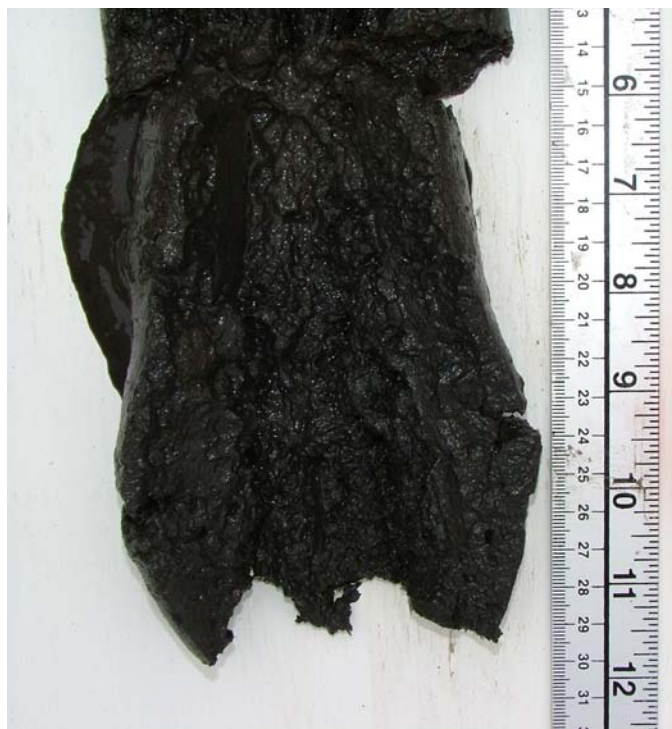
Photo 15.

The sediments near the base of the core. This core was difficult to split due to the high moisture content.

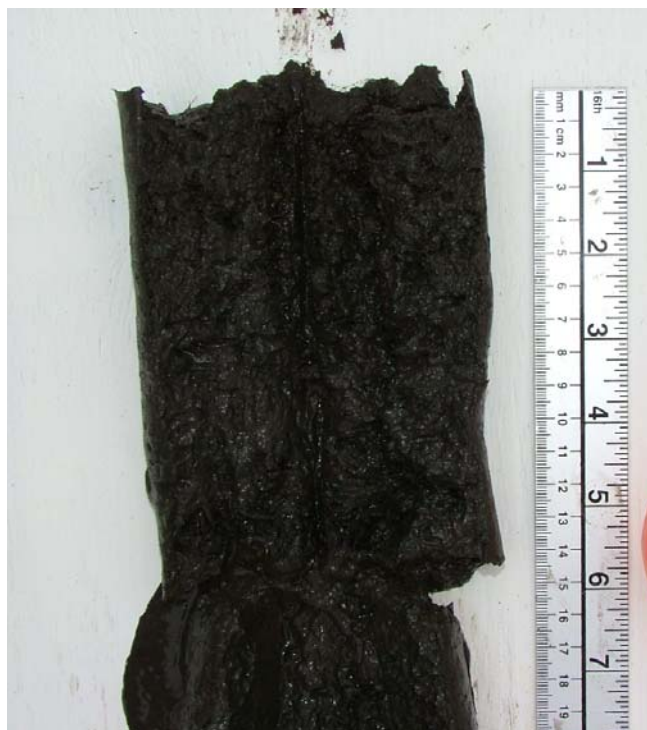
Photo 16.

The sediments near the top of the core.

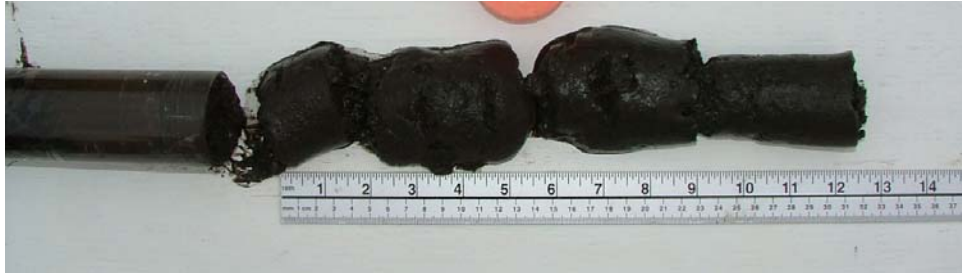
Photo 17.

The sediments were saturated and consisted of massive clay. This core had relatively low organic matter content when compared to the other cores and was difficult to extract from the core tube.

Core 3 was collected near the northeast corner of the pond and was approximately 30 cm in length. Difficulty was encountered when extracting the core from the tube, with the top 6.5 cm of sediment stuck in the core tube. The extracted portion of the core consisted of massive black clay. There were notably fewer organics when compared to all of the other cores. The remainder of the uppermost sediments were removed from the core tube by hand and were consistent with the lower sediments.

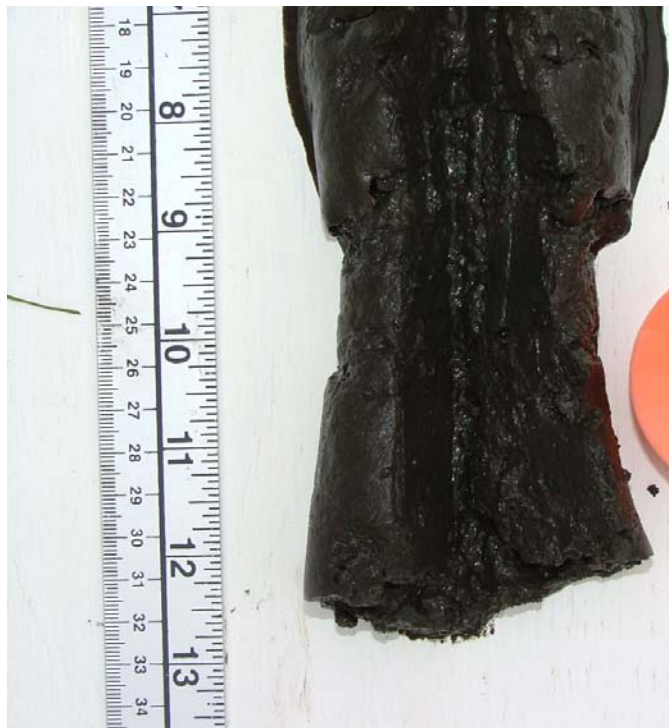
Photo 18.

Sediments near the base of the core.

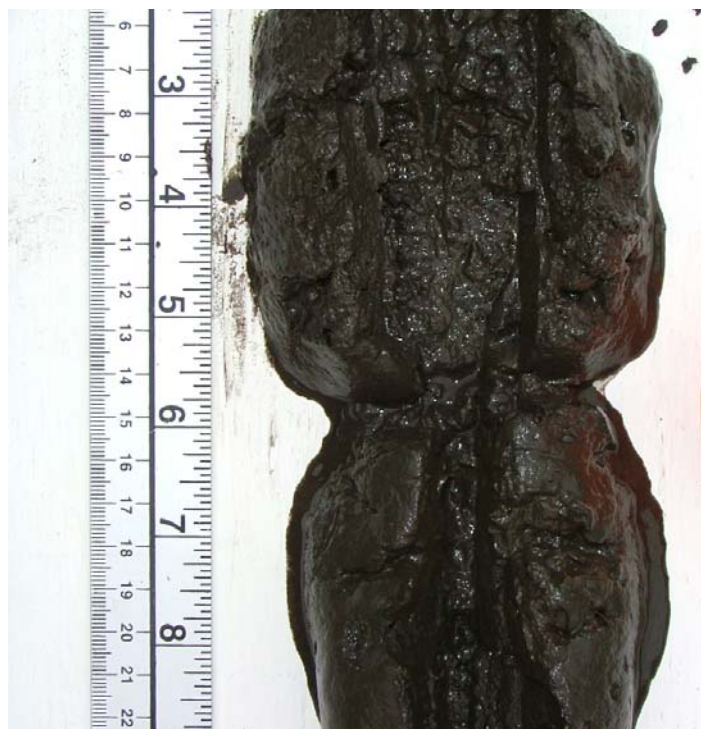
Photo 19.

Sediments in the middle portion of the core.

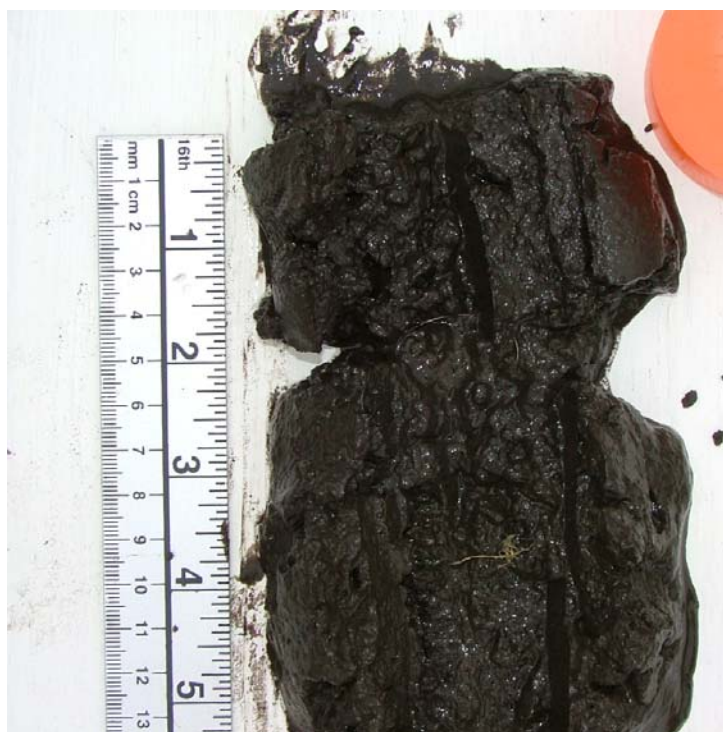
Photo 20.

Sediments near the top of the core.

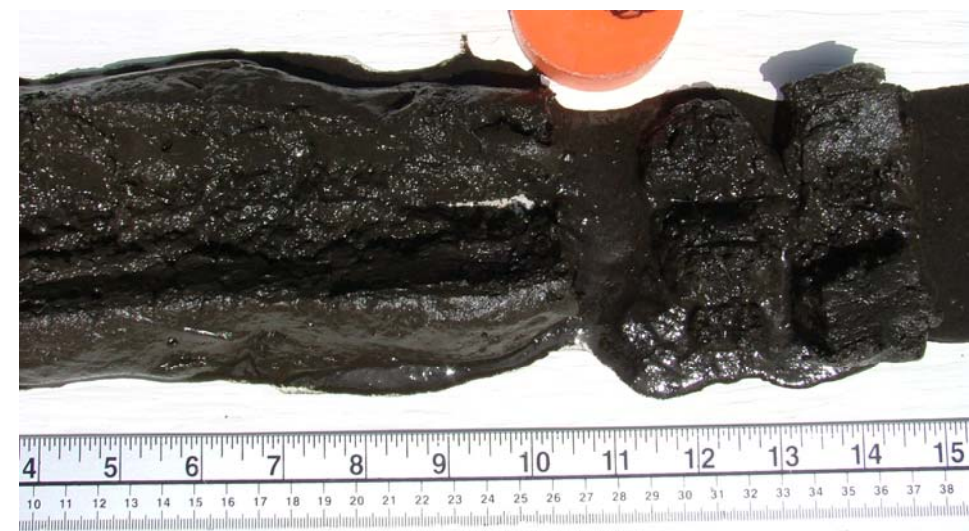
Photo 22.

Sediments near the base of the core.

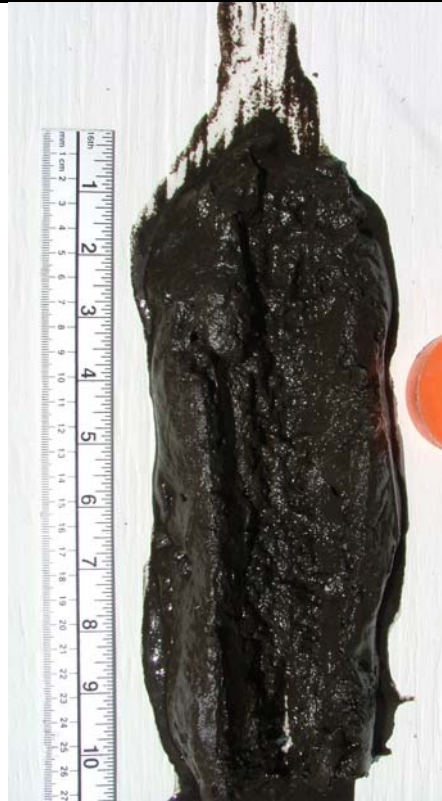
Photo 23.

The sediments near the top of the core.

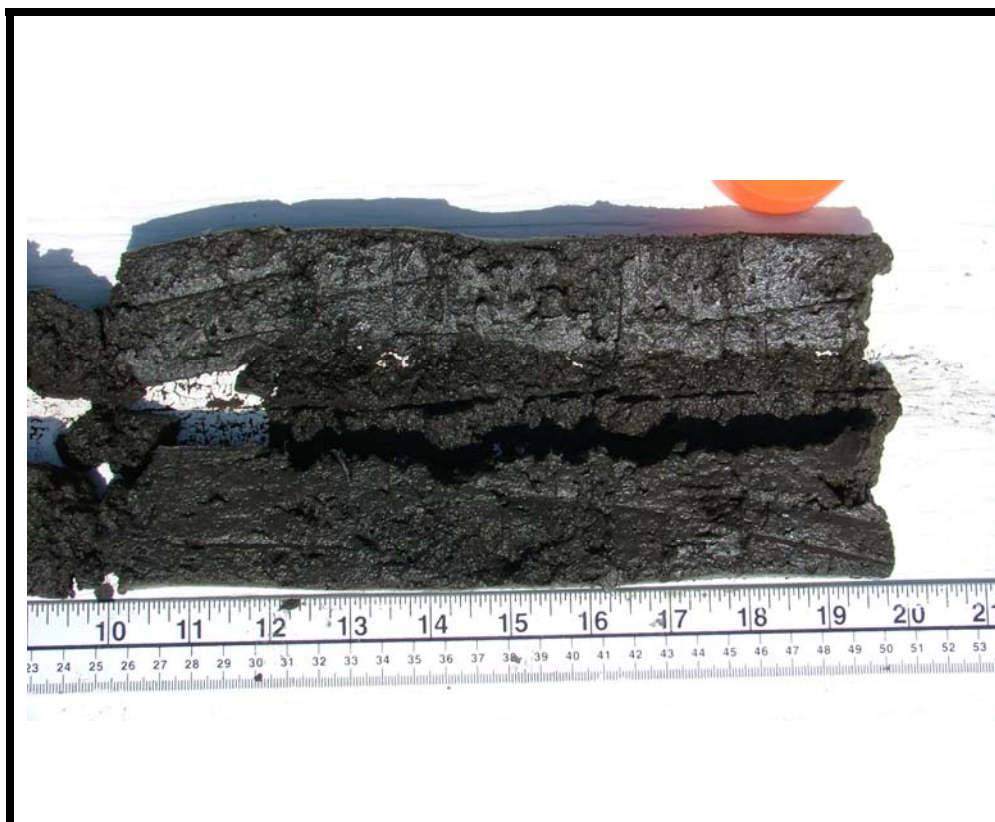
Photo 25.

The sediments near the base of the core were relatively fine grained when compared to the overlying sediments.

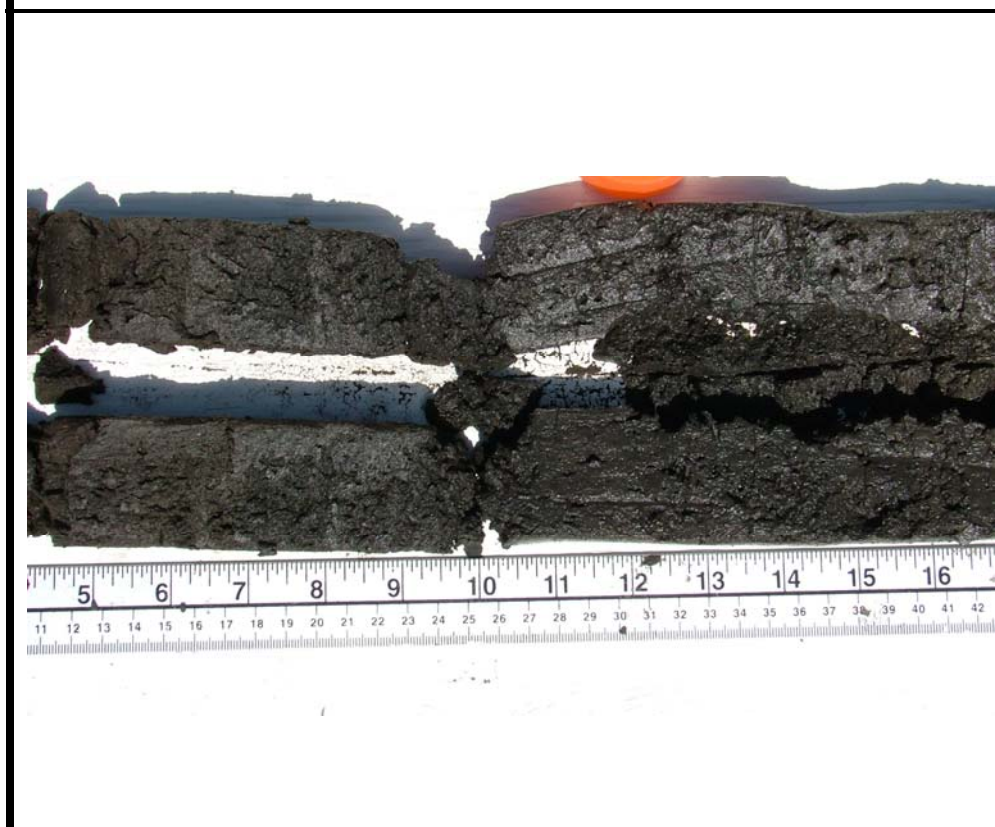
Photo 26.

The middle portion of the core.

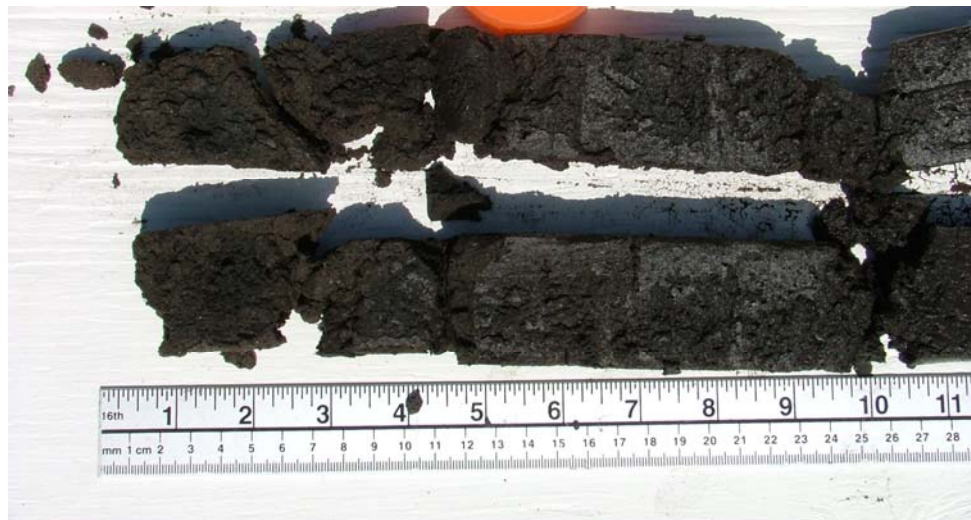
Photo 27.

The sediments near the top of the core contained very fine to fine sand and silt. Although not visible in this photograph, there was a shift in color from black to brown at 17.5 cm depth.
