# Alton Millpond Rehabilitation Project LRIA Application Project Description

September 5<sup>th</sup>, 2017  
Project N° 210-41-HS00171

### Alton Millpond Rehabilitation Project LRIA Application – Project Description

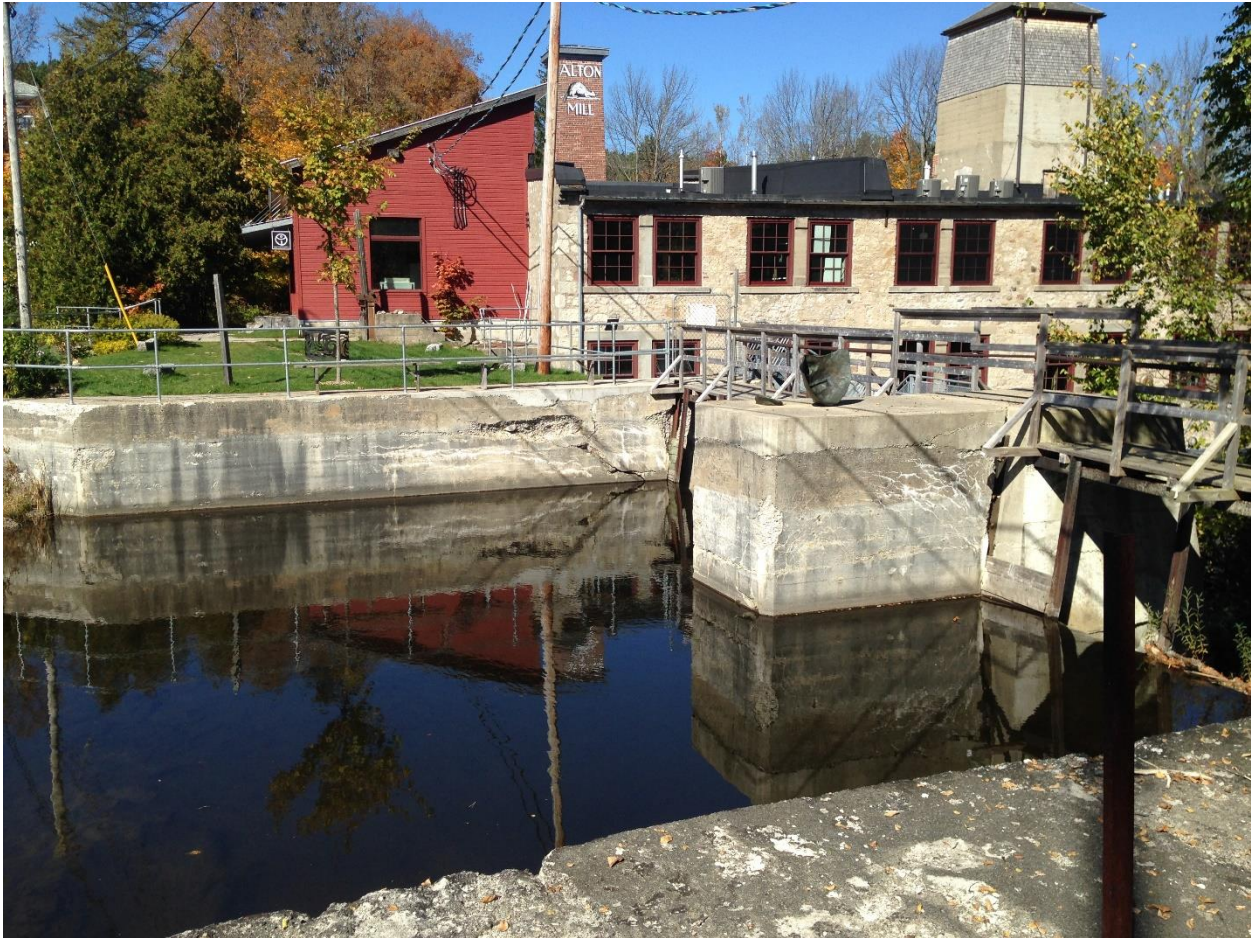
**Figure 3.2 – Existing Dam**

The dam was originally constructed in the 1880's and is part of a heritage stone mill building that currently houses the Alton Arts Center. At present, the sole purpose of the dam is to maintain upstream water levels in the headpond for local recreational uses. Figure 3.2 presents a picture of the current condition of the dam.

The existing dam is a gravity structure and consists of an approximately 3.4 m high fixed weir spanning between abutments and a centre pier. Each spillway opening is approximately 6.5 m wide from face of abutment to face of pier, and approximately 2.3 m high from crest of the weir to top of abutment. Based on site observations, the limited background documentation available, and the construction of the mill building, it is anticipated that the weirs, the pier and the abutments downstream of the weir originally consisted of stone masonry construction which was subsequently encapsulated in concrete. The abutments extend approximately 10 m upstream of the weir as concrete retaining walls which serve to channel flows to the spillways.

Based on background data, the drainage area upstream of the dam is 85 km<sup>2</sup> and the dam's headpond covers an area of approximately 2 hectares. There is significant silt accumulation in the headpond, with the depth of water below the crest of the concrete weir estimated to be less than 0.3 m in much of the pond. The pond level can be raised above the crest of the concrete weir by means of timber flashboards placed in a series of vertical steel supports spaced at approximately 1.2 m centres.

Access for dam operators adjusting the flashboards is provided by narrow platforms spanning between the pier and each abutment. Each platform consists of two steel beams supporting a timber plank deck. A pipe handrail is provided on each side of the platforms, and access to the platforms is impeded by padlocked chain link gates at each abutment.

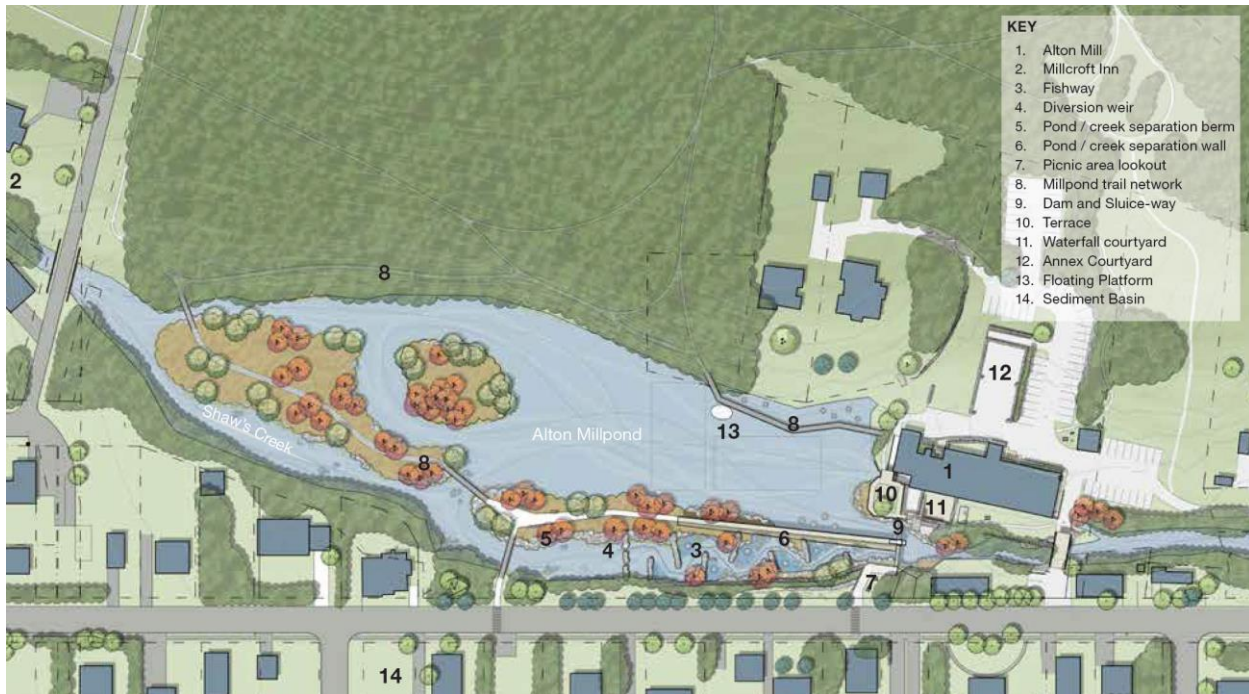
**Figure 3.3 – Proposed Improvements to Alton Millpond Dam**

The new structures will be incorporated into a site landscaping plan, which is not relevant for this application. Appendix A presents the project Master Plan, and Figure 3.3 presents the conceptual general layout of the proposed improvements.

- Replace the existing weir in the dam's North opening by an underflow gate. The sill elevation of the gate will be approximately the existing ground level on the downstream side of the structure. Therefore, sediment dredging in the pond is required prior to the commissioning of the gate to avoid potentially unacceptable amount of sediments travelling downstream. This modification will increase the dam's hydraulic capacity.

- Install a new energy dissipation structure directly downstream of the North opening, in order to control hydraulic jump downstream of the new gate.
- Remove the existing weir to an appropriate elevation in the dam South opening, in order to create a natural-type riverbed to create the downstream end of an appropriately designed fish passage. The South abutment will be rehabilitated, or replaced to ensure slope stability.

- The new inline structure will terminate on the South bank. This portion of weir will form the head of the rehabilitated stream section, and will include a series of openings for controlling flows and allow for upstream fish passage.

The existing structure is essentially inoperable in flood condition. The proposed structure will comprises an under flow gate, and two non-regulated overflow weirs with additional discharge capacity. A new dam operating plan (DOP) will be defined for the new structure. Operation of the dam (under flow gate) will be limited to flood conditions.
